BUILDING DAMAGE ASSESSMENT

Wen Dazhi, BSc, PhD

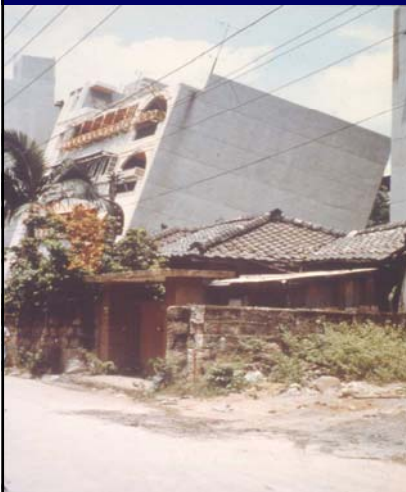
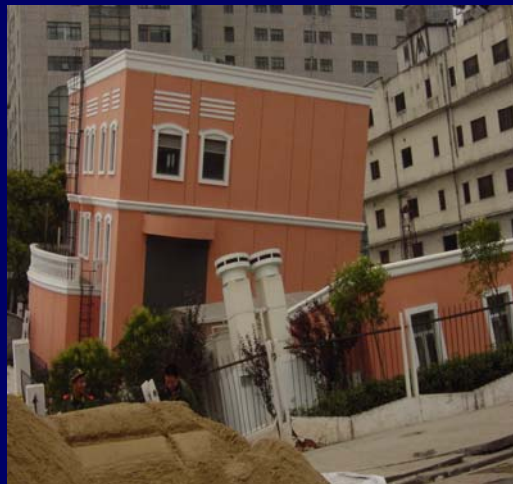
RIGID BODY TILT

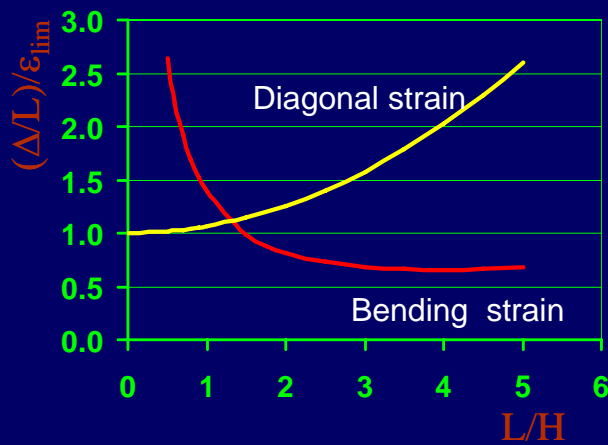
Beam (E/G
= 2.6 for
masonry
structure)
Undergoing
Hogging
with Neutral
Axis at
Bottom
Edge

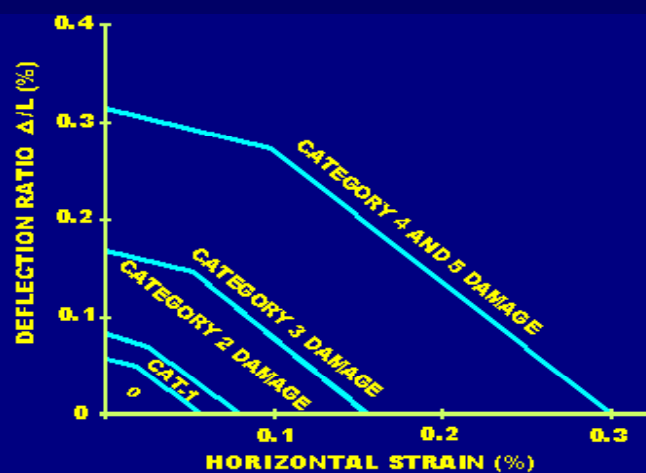
INTERACTION DIAGRAM, Δ/L , ϵ_h & L/H

**DAMAGE CATEGORY CHART FOR L/H=1,
HOGGING MODE
AFTER BURLAND (1995)**

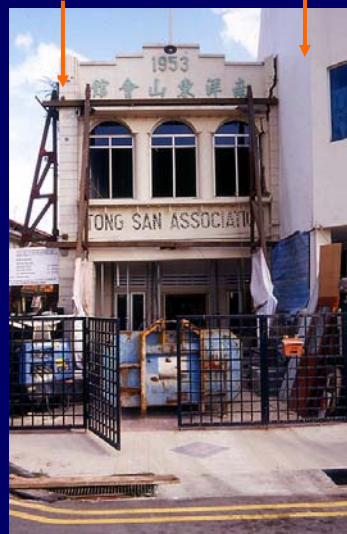
Settled by 107mm

No 146, piled

Building tilting away from the adjacent structure

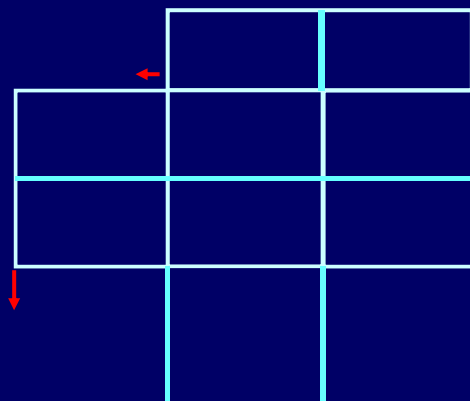
Adjacent buildings on different foundations: Old buildings on footings butted against newer buildings on deep foundations.

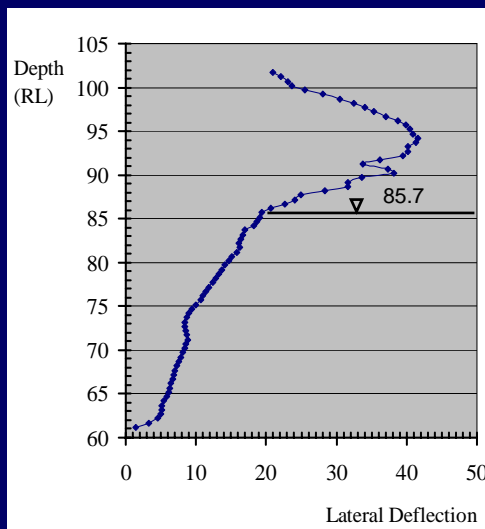
Lateral Soil Movement in Front of the Mosque

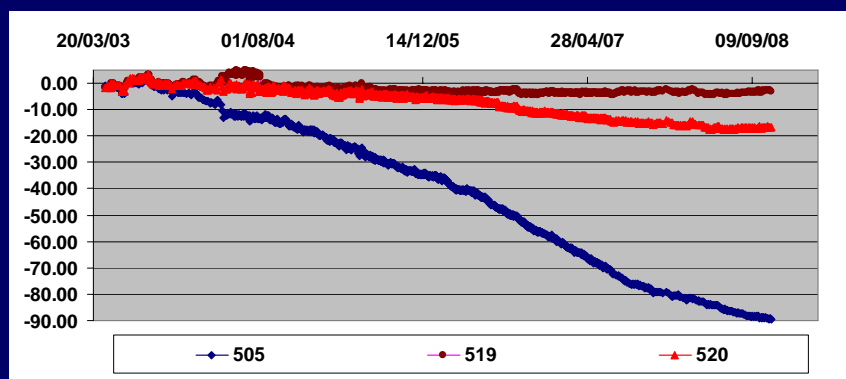
Building Settlements

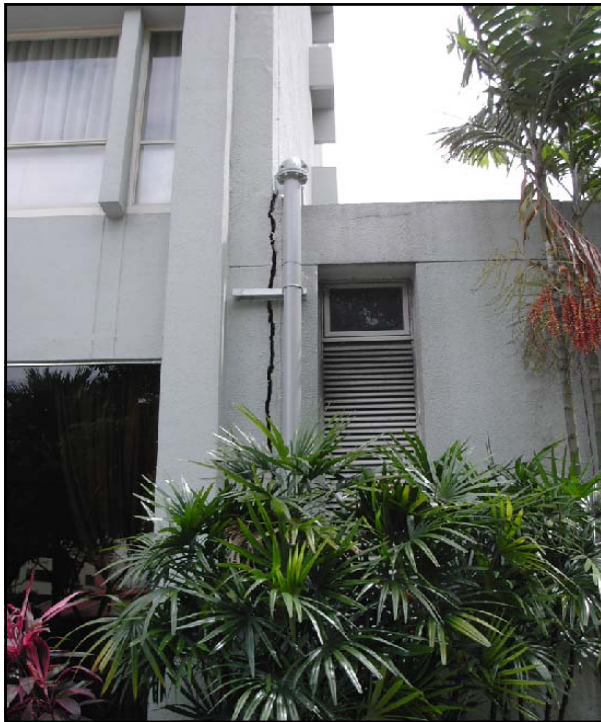
**Annex structure
on footings
abutting buildings
on piles**

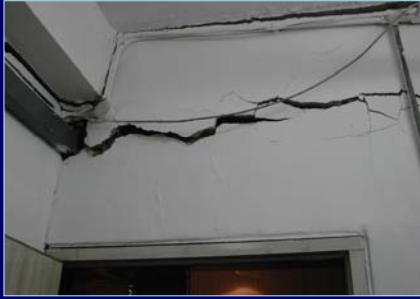
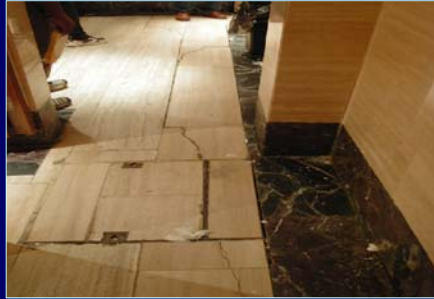
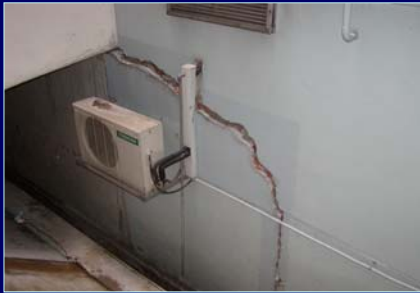
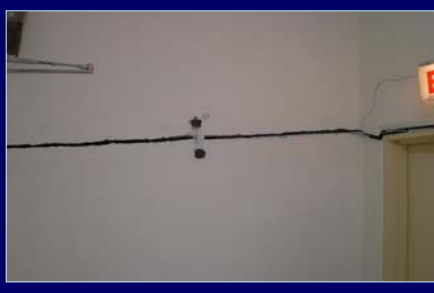
STAR SINGSATION KTV CLUB

Walkway - piled

Main load bearing column - shallow foundations
